## Tree Condition Assessment Prepared for

Dittisham Parish Council  
Dartmouth  
Devon

Date: 14<sup>th</sup> September 2026  
Version: 1

| Location: | The Ham<br> Car Park at 'The Level' Dittisham<br> Capton triangle | | |

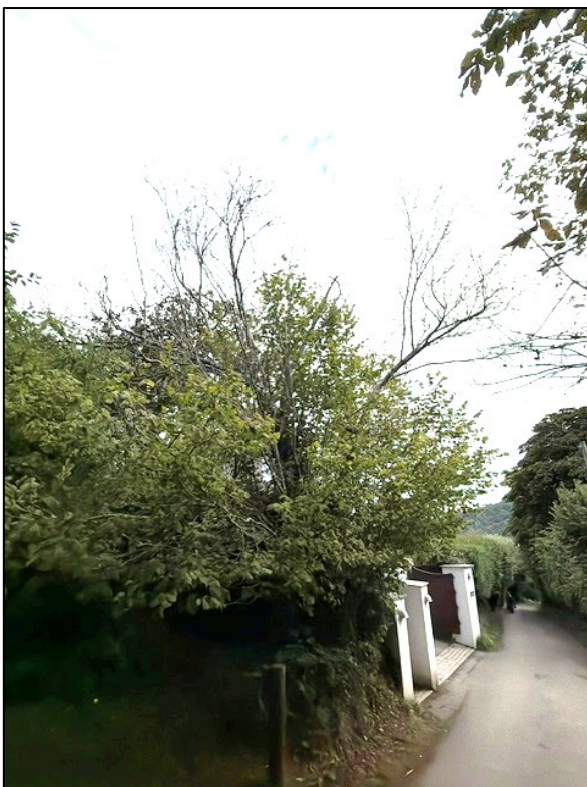
Further along the lane towards the triangular seating area, there is a declining hazel growing on the old hedgebank outside Riverside House. The tree has several dead stems, which should be removed.

Photographs 1 and 2: Declining hazel next to Riverside House (left) and ash on The Ham (right).

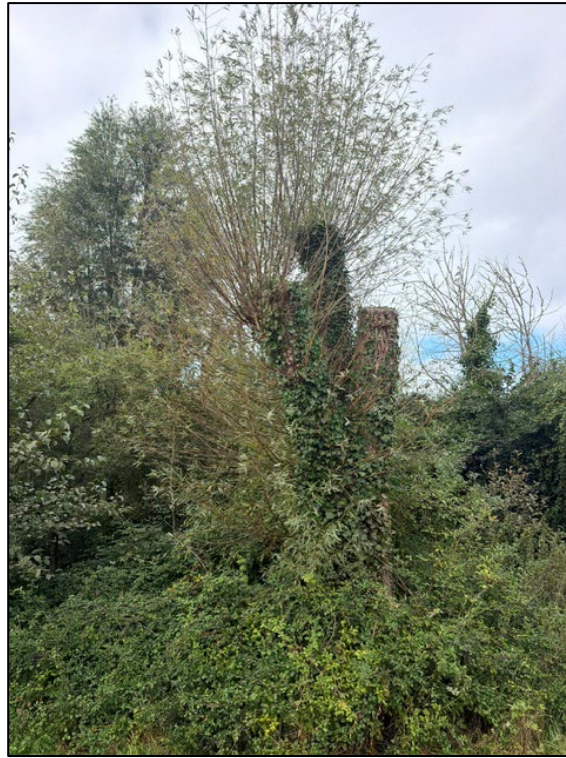
- 4.1.4 T19 is a willow tree which was pollarded approximately two years ago. The tree has significant decay and internal hollowing within the main trunk and should be routinely pollarded to reduce the likelihood of stem failure. At present, some of the regrowth from the recent pollard points appears to have died back, which may be associated with the prolonged dry weather experienced during the last two summers. However, parts of the tree remain relatively unaffected.

*Photograph 3: Willow showing decline and dieback at pollard point.*

| Tree No/<br>ID | Tree Species | Age<br>Range | Height (m) | Spread<br>(m) | Stem<br>Dia.<br>(mm) | Structural<br>Condition | Vitality | Comments | Management<br>Recommendations | Target<br>Range | Size<br>Range | PoF | Risk<br>Index |
|---|---|---|---|---|---|---|---|---|---|---|---|---|---|
| 19 | White Willow<br>– <i>Salix alba</i> | EM | 4 | 2 | 800 | M | G | • Recently pollarded at approx. 4 metres due to decayed main trunk and internal hollowing most likely caused from Phellinus spp. Decay fungi | • Pollard lower down at crown break (3 metres in height) retain all lower growth on trunk and stems. | 2 | 1 | 5 | 400K |

The pollard height remains relatively high and the main trunk is significantly decayed. It is therefore recommended that the tree is re-pollarded lower down, at the main crown break, at approximately 3 metres above ground level. All lower growth should be retained, however small. The sections of timber removed from the works can be stacked within the scrub area at the rear of the tree. The tree may continue to produce new growth from the retained lower trunk and could potentially develop into a lower-growing tree over time.

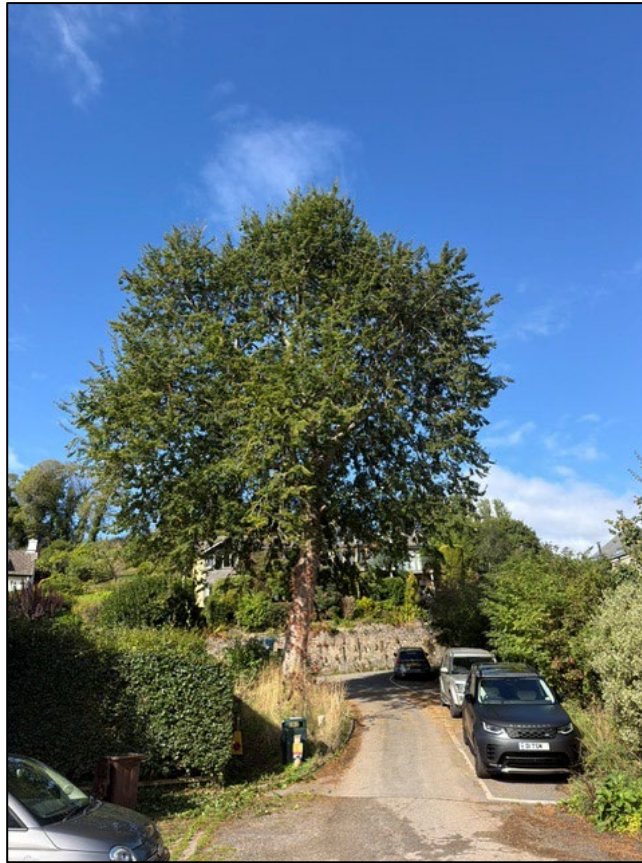
- 4.2.1 There are three trees located at The Level car park. T0025 is a large southern beech (*Nothofagus procera*) growing at the entrance of the car park on the southern boundary. The tree has a large crown and the tree appeared to be thickening in foliage during the last inspection as it recovered from previous pruning. During this inspection it is clear that this tree has responded well to the pruning and the crown appeared dense and the tree physiologically healthy. At the time of the inspection no significant risk features were observed with this tree.

- 4.2.2 A large branch failure or removal in the lower crown on the western aspect of the crown has occurred at some point. The soil from around the tree has been removed and a young rowan has been planted close by. Grass has been left uncut which benefits the tree. The large salt grit bin has now been re-located.

*Photograph 4: View of southern beech in good condition.*
